Docket No. 217 – Development and Management Plan Inspection

Northeast Utilities Service Company Certificate of Environmental Compatibility and Public Need for the construction of a 345-kV electric transmission line and reconstruction of an existing 115-kV electric transmission line between Connecticut Light and Power Company's Plumtree Substation in Bethel, through the towns of Redding, Weston, and Wilton, and to the Norwalk Substation in Norwalk, Connecticut.

Date: May 14, 2004

Location: Norwalk Substation Expansion

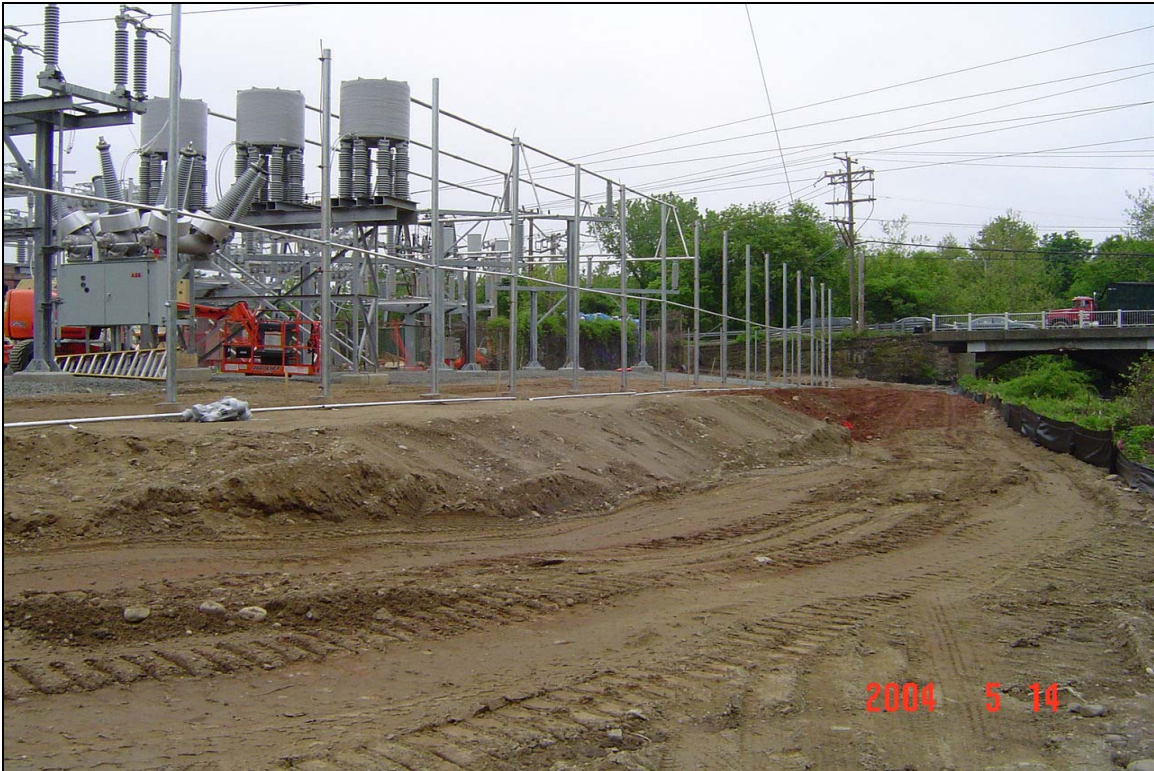
VIEW OF NEW EXTENTS OF THE SUBSTATION YARD. A FENCE WILL BE COMPLETED SOON AND GRADING IS ONGOING FOR THE ADJACENT BIKE PATH.
5/14/04

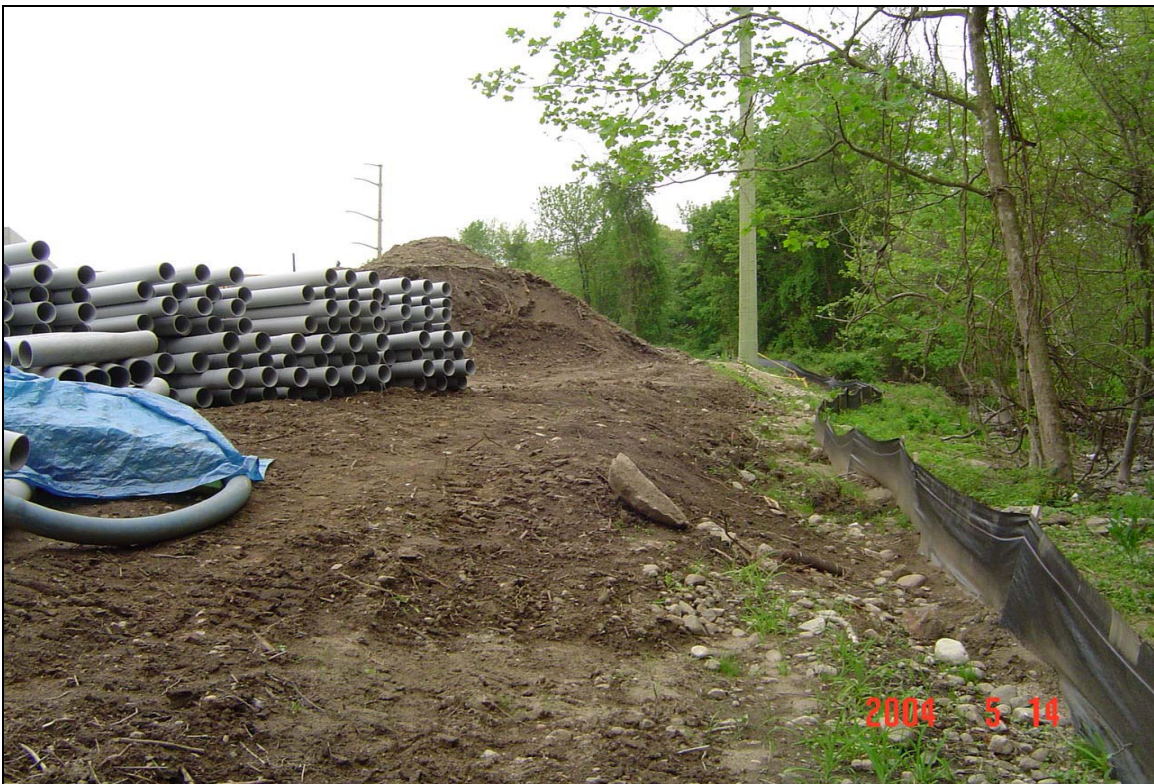
- Portions of the northerly portion of the stockpile have been used on site. The area was flattened for access and some soil was removed. 5/6-5/14/04	- The pile appears fairly stable but should continue to be monitored. Plans are ongoing to utilize most of the soil in the near future. 5/14/04

NORTHERLY PORTION OF THE SOIL STOCKPILE. SOIL IS BEING PULLED FROM HERE AND UTILIZED ON SITE. VEGETATION IS RETURNING ON THE BANK 5/14/04

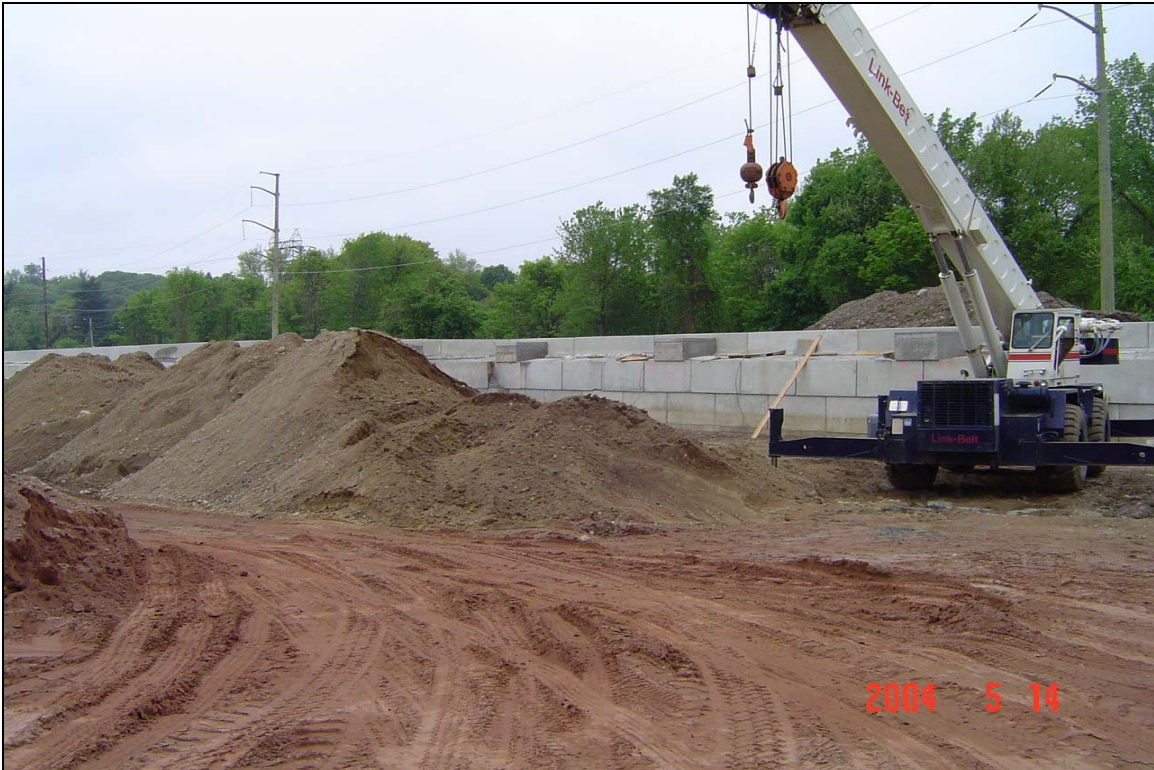
- Soil is being stockpiled near retaining wall #1 and is being removed from the site. This is the only area on site to have received soils from a borrow pit in Monroe. 5/14/04	- The piles are well contained within the site at this time, and they will be completely removed in the near future. 5/14/04

WALL #1 WHERE THE MONROE SOIL IS BEING REMOVED AND STOCKPILED UNTIL IT IS REMOVED FROM SITE. 5/14/04

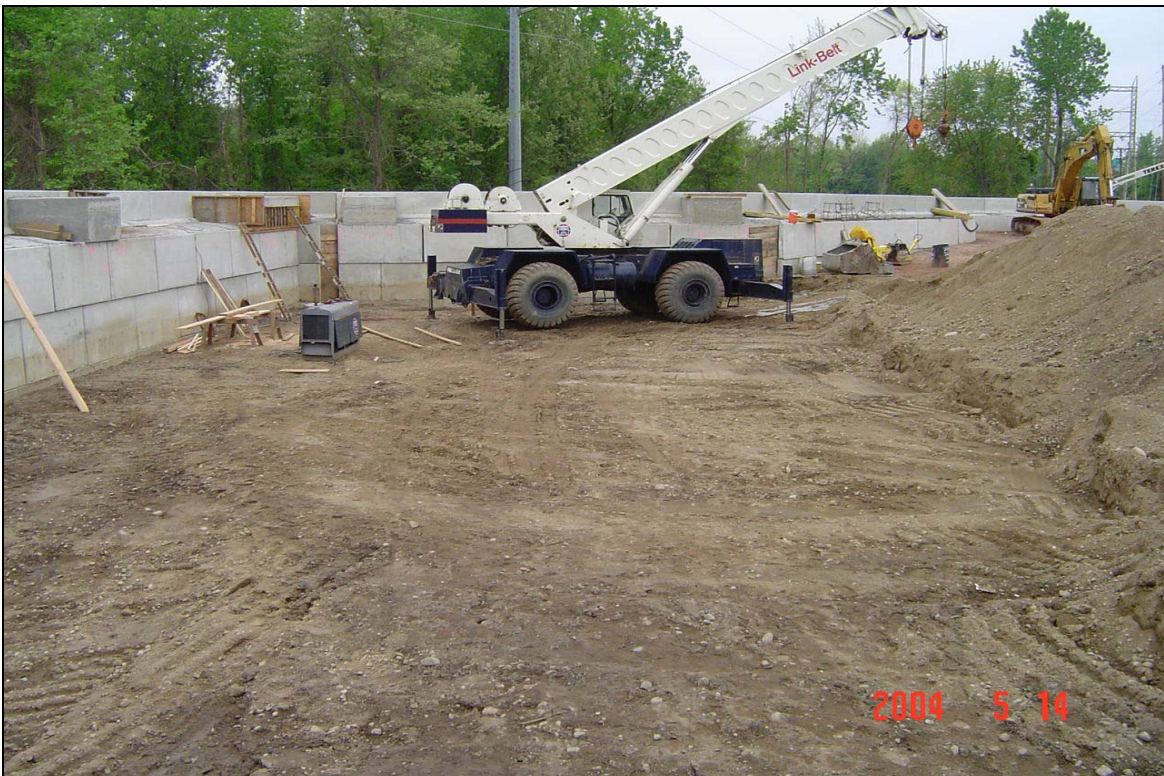
VIEW OF WALL #1 EXCAVATED TO PREVIOUS GRADE AND THE SOIL WILL BE REMOVED FROM SITE. 5/14/04

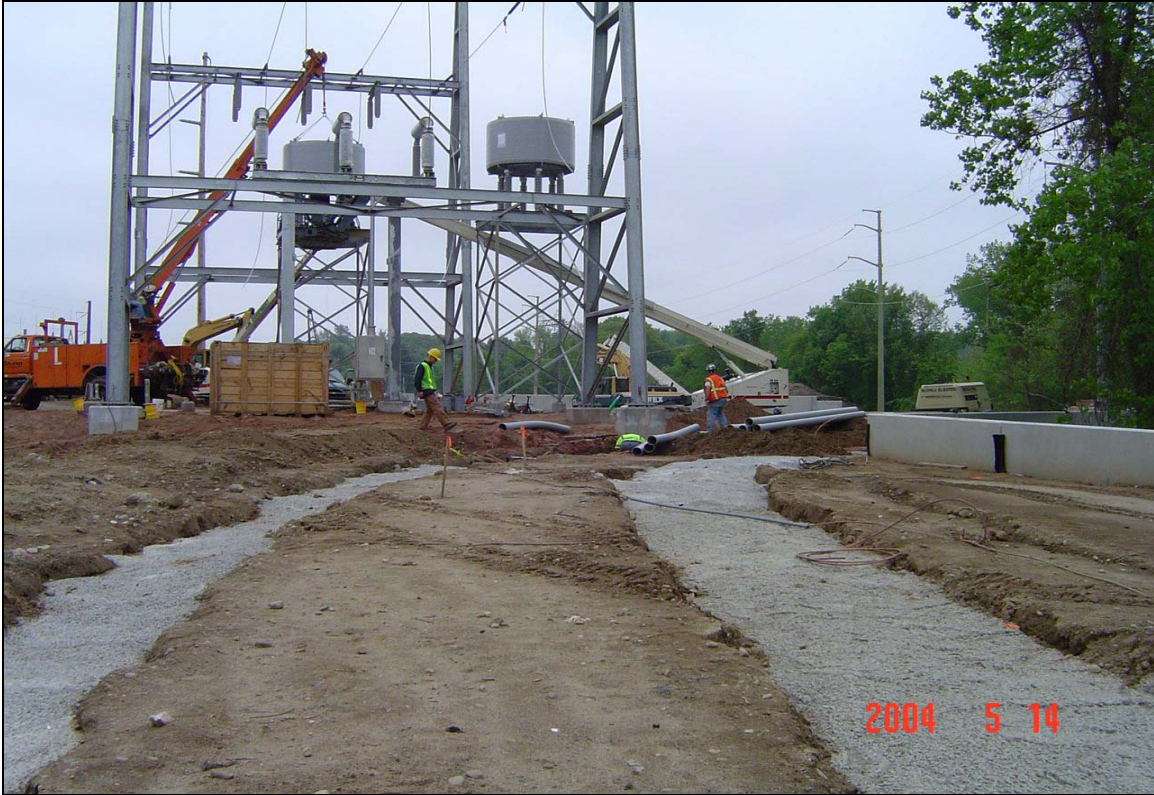
VIEW OF CONDUIT BANKS COVERED IN CONCRETE. TRENCHING CONTINUES FURTHER INTO THE SITE. 5/14/04

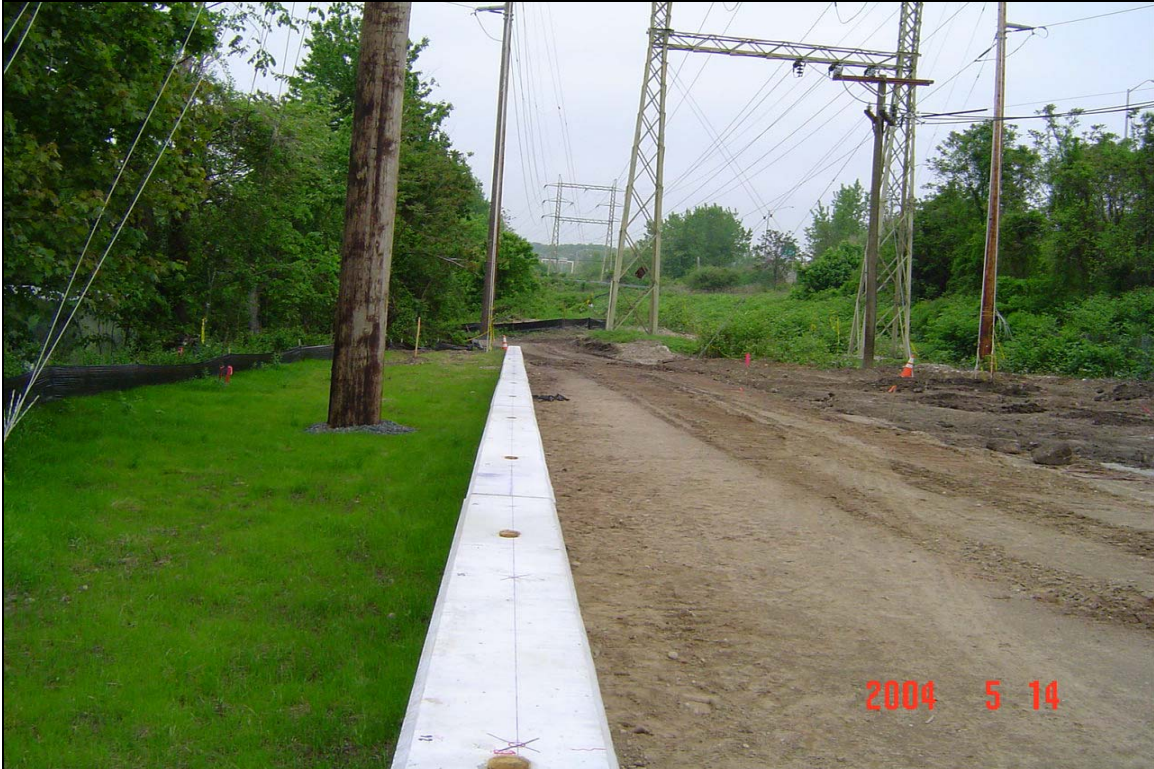
VIEW OF WELL ESTABLISHED GRASS COVER AT THE NORTHERN PORTION OF THE SITE. 5/14/04

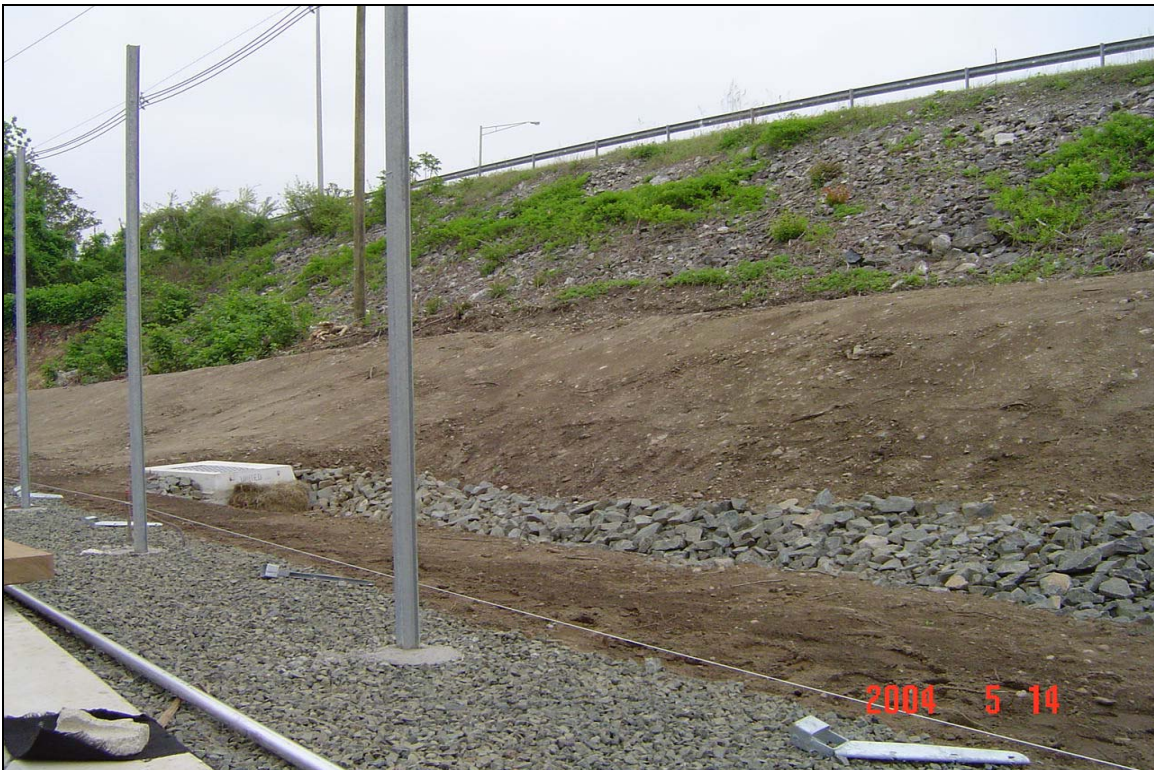
- The area below the Route 7 ramp and above wall #4 has been graded and loamed 5/14/04. - A catch basin is located here at the end of the swale with a top and side inlet. A haybale has been placed at the side to prevent sedimentation to the catch basin but this may not be the permanent solution. 5/14/04	- The area is scheduled for hydroseeding within the next few days. This will reduce any potential sedimentation to the catch basin as well. 5/14/04

THE AREA BELOW THE ROUTE 7 RAMP HAS BEEN BROUGHT TO FINAL GRADES AND WILL BE HYDROSEEDING IN THE NEAR FUTURE. 5/14/04

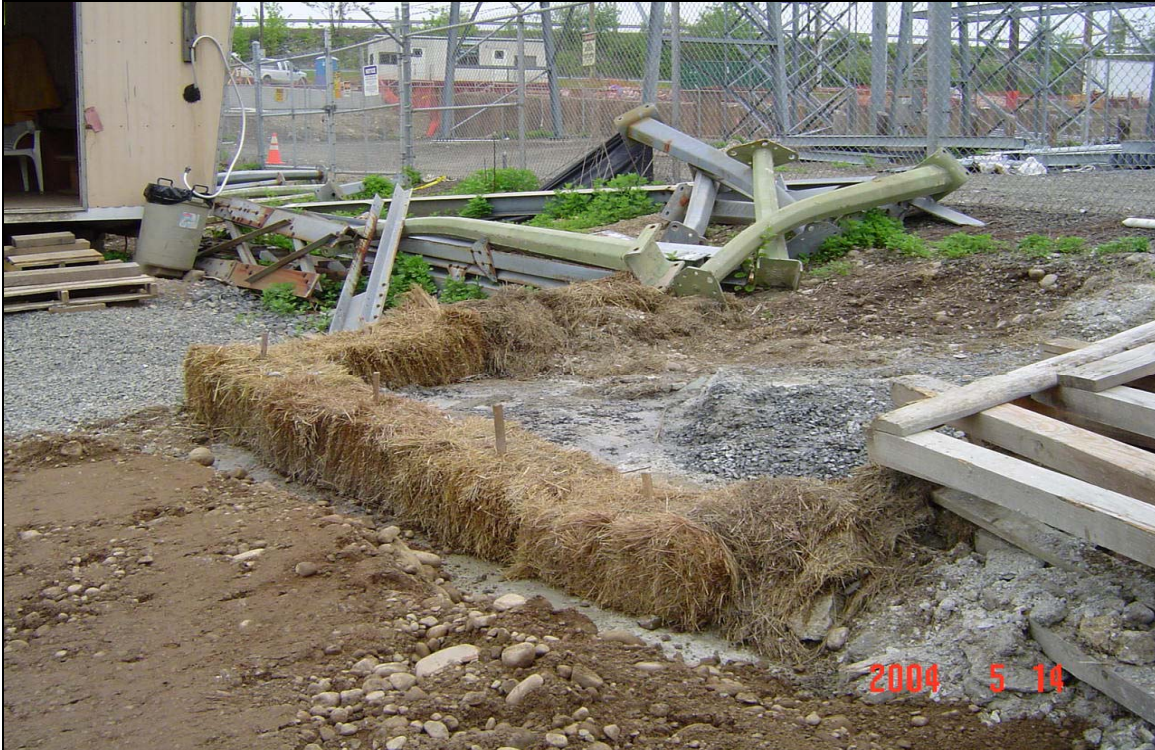
- The concrete washout station haybale controls have been maintained however a concrete washout was noted in another area on site for the first time in a while. 5/14/04	- The washout is well contained on site however, continue to utilize designated stations for concrete. 5/14/04

THE CONCRETE WASHOUT STATION CONTROLS WERE MAINTAINED. HOWEVER ONE CONCRETE WASHOUT WAS NOTED ON SITE. 5/14/04
